## Polychrome from the southern crypt of the church of the Holy Trinity in Byszewo in light of archaeological and conservation studies

Nowak S., Kaźmierczak A. 2019. Polychrome from the southern crypt of the church of the Holy Trinity in Byszewo in light of archaeological and conservation studies. *Analecta Archaeologica Ressoiviensia* 14, 169–185

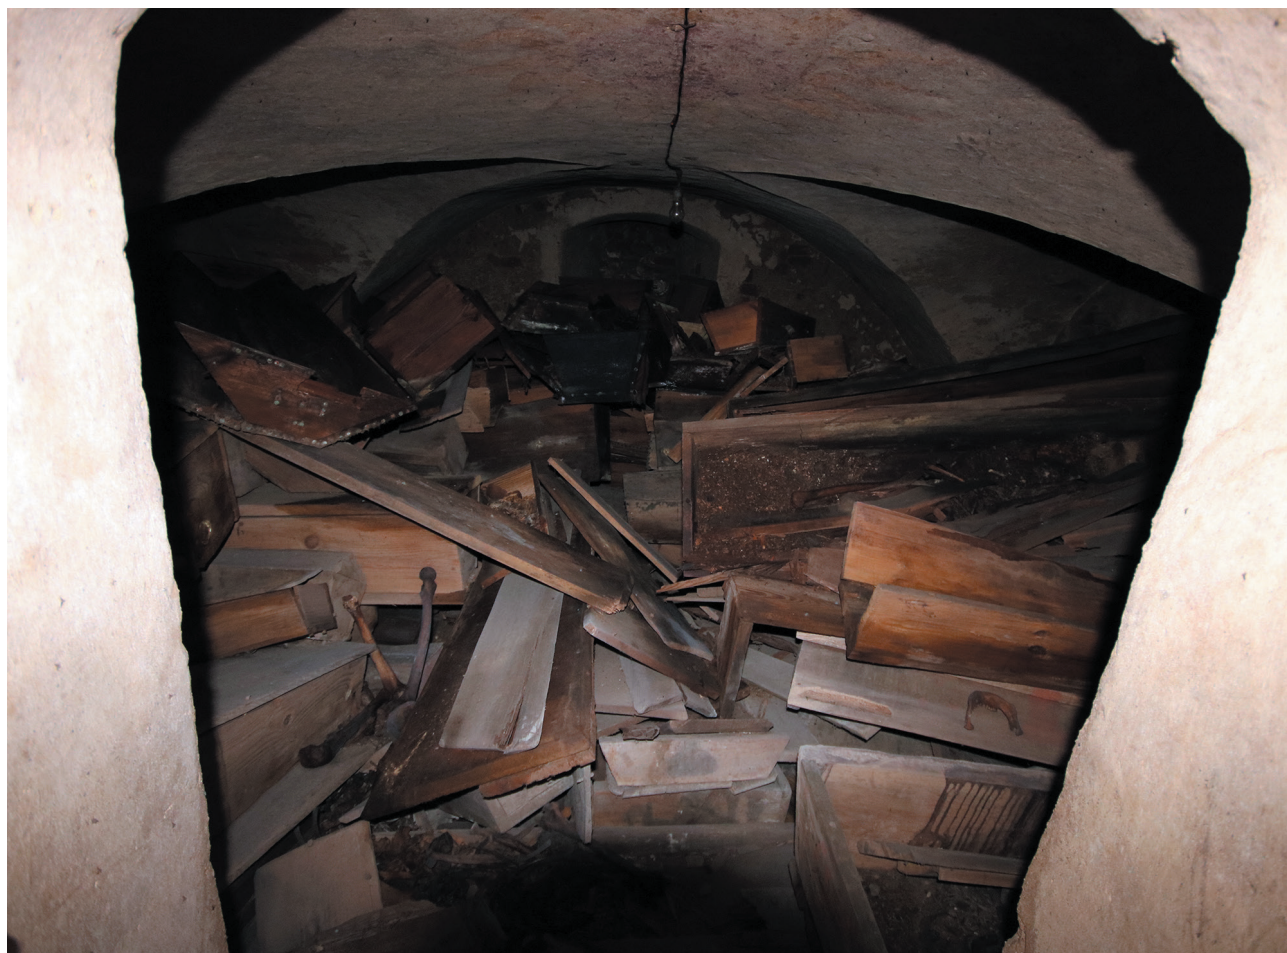
**Fig. 1.** The state of the southern crypt after removing the protective wall which had closed the entrance. Irregular burial layers seen throughout the whole space. Photo by M. Majorek.

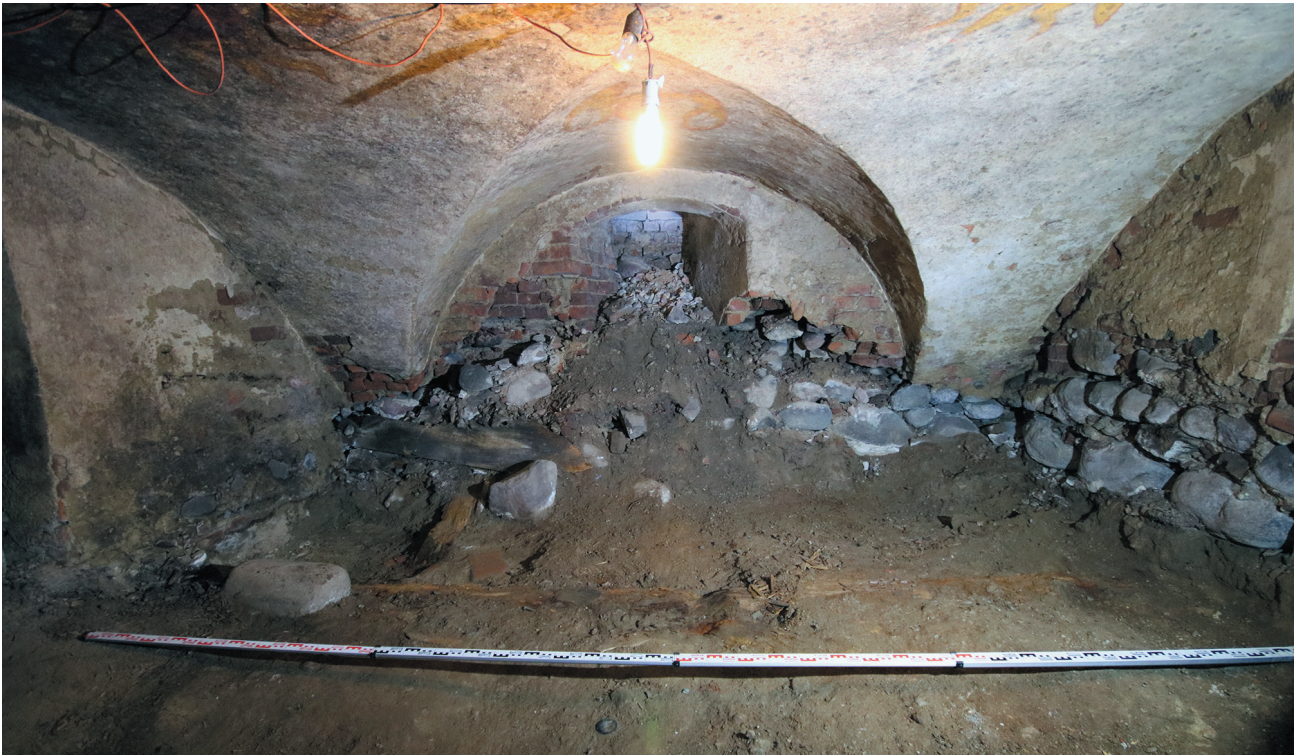
Fig. 3. The crypt's eastern wall: with a ventilation-light opening, the wall's destruction and original wooden joists visible in the crypt pugging. Photo by S. Nowak.

The southern crypt was erected on a rectangular plan with sizes 430 \* 460 cm, with a shift of south-eastern corner. Its walls are compatible with the foundations of the Passion chapel above. Wooden joists (Fig. 3) were identified under the burial layers, which originally served to place the coffins on to protect them from direct contact with the pugging of the floor. The floor had places with identified layers of lime mortar, being signs of the plastering of the crypt vaults and walls (Grupa and Nowak 2019, 6, 12).

The eastern (Fig. 3), southern and western walls were equipped with one light ventilation hole each, protected with grates. This probably contributed to the good state of preservation of the grave goods and human remains, which naturally mummified. The situation changed after the bricking up the holes, which caused a lack of air circulation and growing humidity, which finally led to gradual degradation of burials, walls (Fig. 3) and painted decorations in the crypt.

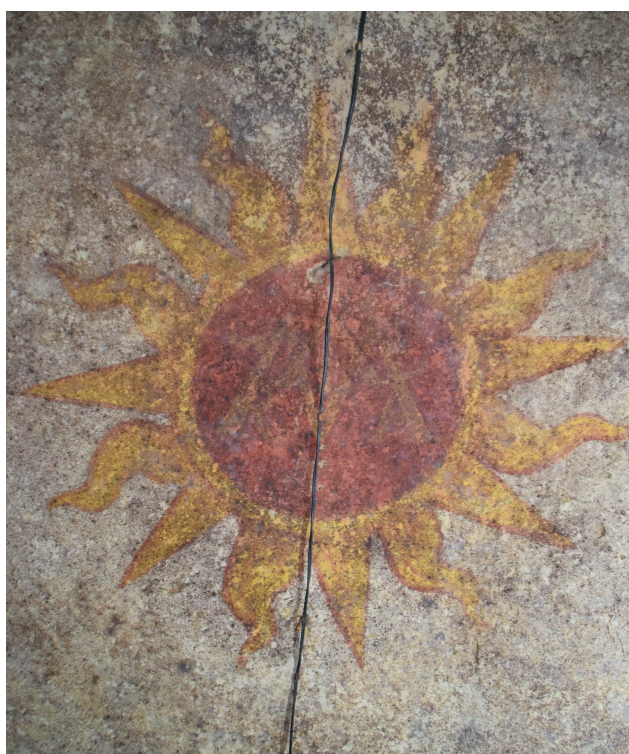
Fig. 5. Solar disc with the cipher *Maria* in solar glory on the barrel vault from the northern side. Photo by A. Kaźmierczak.

The monogram *Maria* (Fig. 5) consists of entangled decorated letters with serifs. The base of the composition is a capital letter “M” with decorative weaving edgings at the sides, and “A” and “I” composed in the middle, with the side arms marked by the letters “R” and “A” directed inside. The Christogram *IHS* is visible practically only in the picture made using UV light and after computer processing. This made a considerable contrast between the background and the drawing (Fig. 6). Letters with serifs were also used in this case. The horizontal line of the “H”, breaks upward in the middle, making a triangle finished with a cross with serifs. Below the line, there are three crossed nails. The UV light photo shows two diagonal lines between the letters “I” and “H” (Fig. 4), which can be interpreted as the author having changed the composition of the letters while painting.

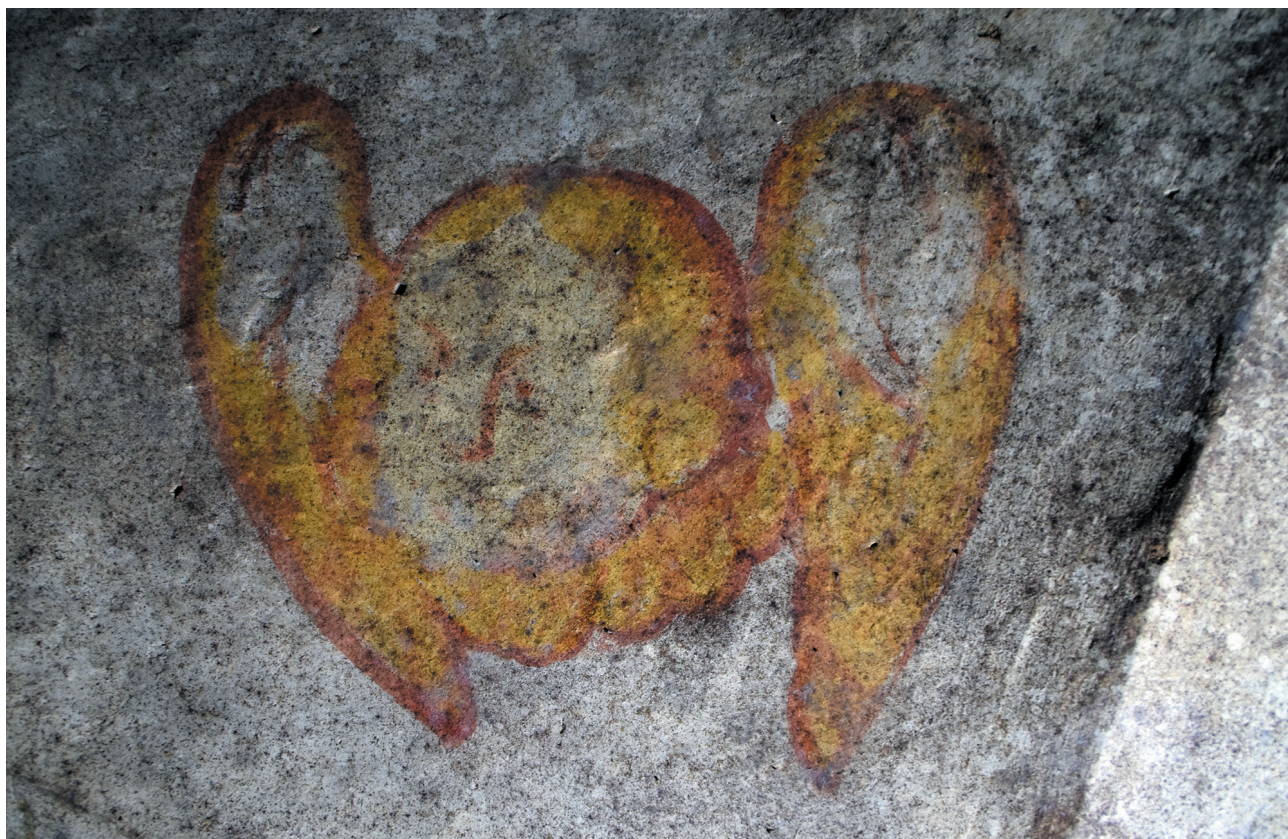
**Fig. 7.** Putto in the eastern lunette. Photo by A. Kaźmierczak.

The putti are painted similarly, but the western one is preserved in a much poorer condition than the eastern one (Fig. 7–8). The figure composition was made here first of all using a red line. Their yellow faces are round and chubby. Only the large almond eyes and straight noses are schematically marked with red, and the lips were probably made in the same way (the least readable). The putti's yellow hair is short, with red painted weaves and locks. Under their heads there are single fragments of feathers and, at the sides, yellow-or-

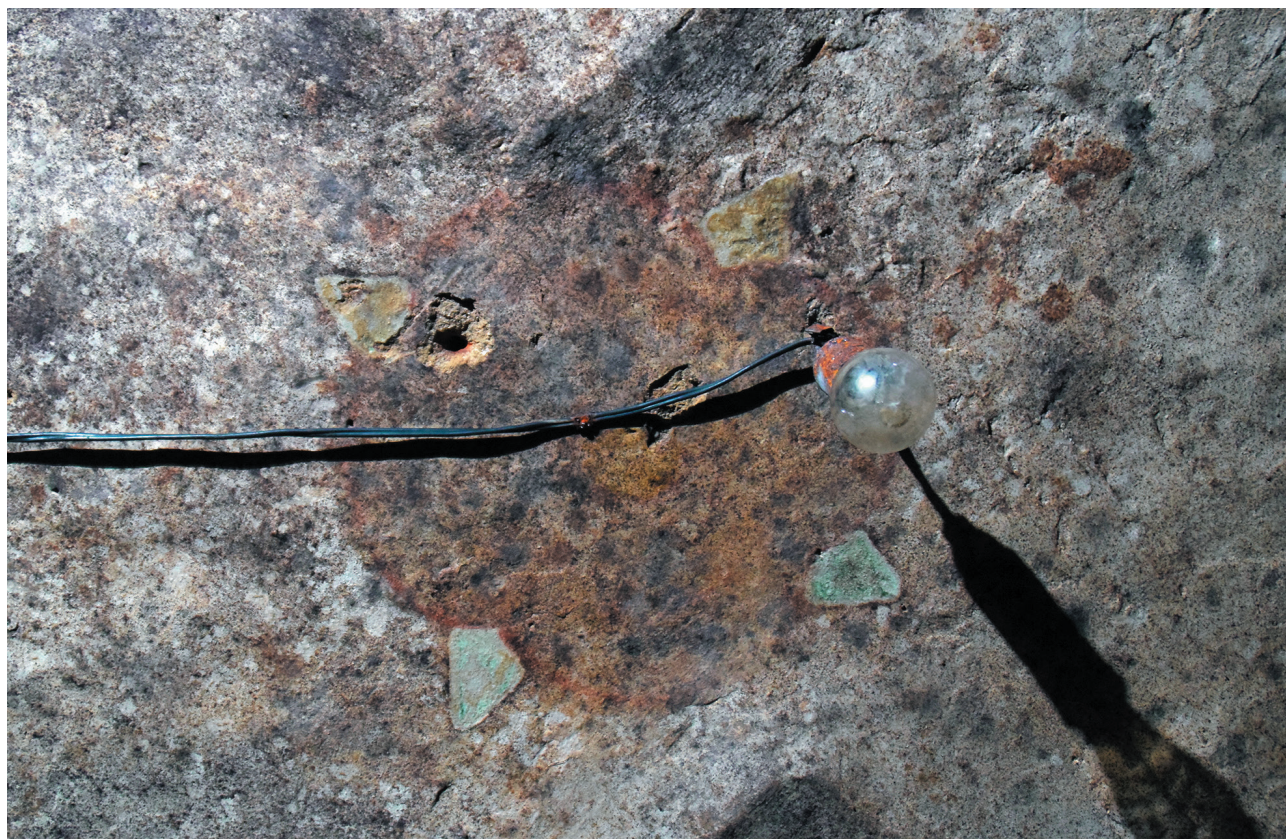
Fig. 9. A flower in the central crypt vault section. Photo by A. Kaźmierczak.

A primitive flower in the middle of a vault (Fig. 9) has four rounded bright orange petals with a small round yellow center lined in red. Straight malachite leaves are small and close triangles. All elements are lined in red.
