Joanna Trąbska, Barbara Trybalska

## **Microstructure of Historical Lime and Lime – Hydraulic Mortars: from Setting to Corrosion**

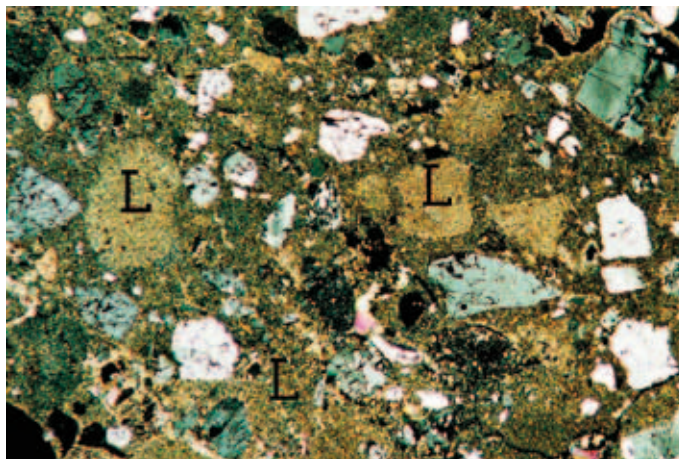
Fig. 8. 16<sup>th</sup> century mortar from Czudec Castle. Lumps (L), separated from binder. Their origin is explained in the text. Crossed polars, magn. x 25. Phot. M. Doktor.

Ryc. 8. Zaprawa XVI-wieczna z zamku w Czudcu. Grudki (L) wyraźnie oddzielające się od spoiwa. Ich powstanie objaśnione jest w tekście. Polarizatory skrzyżowane, pow. 25x. Fot. M. Doktor.

In historical mortars quite often fine-crystalline, lime (Fig. 8) or „hydraulic” (Fig. 7) lumps are observed. Their internal structure and composition may be identical with a surrounding binder but they are more or less sharply separated from it. Lumps with sharp borders (Fig. 8) are interpreted as having been appeared either during lime slaking with poor access of water (then certain volumes remain unslaked and are transformed to calcium carbonate later; Mora et al. 1983, 51), or as a result of uneven conditions of firing processes, with remaining lumps of not utterly fired limestone. In the latter case certain primary features

gative aspects of lumps presence there are some positive ones: it is stated that they help in slower and more homogeneous calcification of slaked lime, thus acting as filler (*op. cit.*). Structurally, some lumps tend to separate from a wet binder whilst others remain an integral part of it (Fig. 7, 9 and 8).

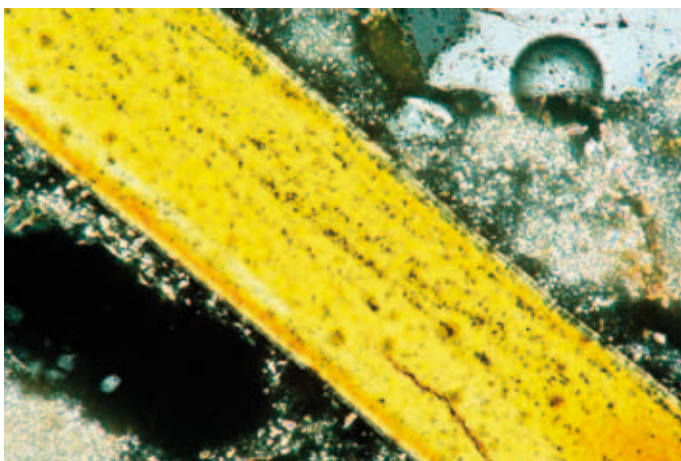
Fig. 12. 14<sup>th</sup> century mortar from Czudec Castle. Fragment of a microorganism, filled with secondary iron compounds. Crossed polars, magn. x 400. Phot. M. Doktor.

Ryc. 12. Zaprawa XIV-wieczna z zamku w Czudcu. Fragment mikroorganizmu wypełnionego wtórnymi związkami żelaza. Polaryzatory skrzyżowane, pow. 400x. Fot. M. Doktor.

Thus, they cannot be regarded as a proof for an 'old age' of mortars. Calcification of organic remnants is a result of percolation of water (either of internal or external, environmental origin) rich in calcium and carbonate ions. Other minerals than calcite may also replace microorganisms, like iron oxides noted in mediaeval mortar (Fig. 12).

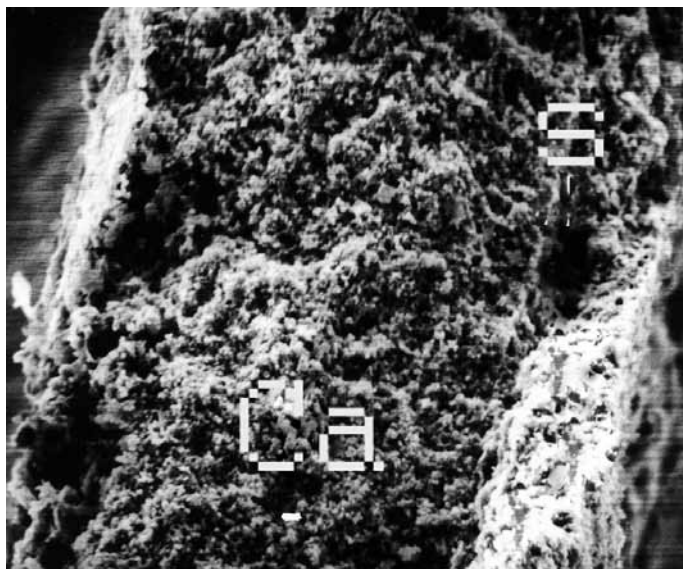
Fig. 20. Mediaeval plaster from under a wall painting from the church in Kurów Wielki near Głogów, Lower Silesia. Sulphur is concentrated on a contact between plaster and painting layer and within painting layer, without any visible crystalline forms.

Magn. x 1100.

Ryc. 20. Średniowieczna zaprawa gruntująca (grunt) spod malowidła ściennego w Kurowie Wielkim koło Głogowa, Dolny śląsk. Na kontakcie warstwy gruntu i malowidła koncentrują się związki siarki, nie tworząc wyraźnie widocznych skupień. Pow. 1100x.

Another, less comfortable situation is also possible: even under several thousand times of magnification no phases are observed and yet chemical analysis gives evidence for the presence of “corrosive” ions. Examples are numerous; one of them is a plaster from under the Gothic painting layer in the Kurów church (Lower Silesia Province), where sulphur was detected due to the microchemical analysis (Fig. 20)<sup>5</sup>. This phenomenon was well confirmed by the experimental works (Trąbska 1998, 236-257).
